Why buildings collapse in the earthquakes, Turkey case

Ali Serdar ECEMiŞ

Necmettin Erbakan University, Civil Engineering Department, Konya-Turkey

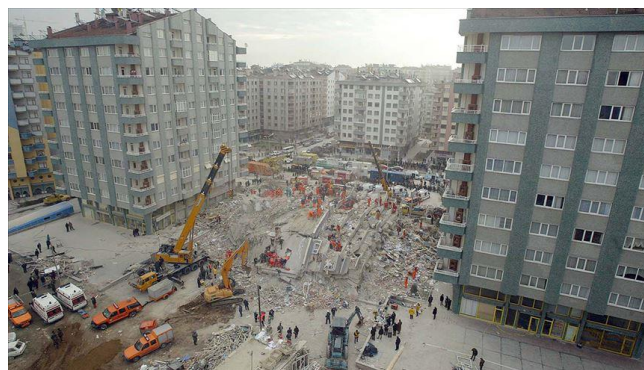
The biggest problem in housing construction was poor quality concrete production. In parallel with the technological level of the country, ready-mixed concrete production had become widespread after 1995. Concrete production was done by workers at construction sites. In some cases, concrete was mixed with shovels without using a machine. It was impossible to comply with the design mixture, water / cement ratio in production. A high amount of water was used for easy concrete casting. According to the experience of the author, strengths of 7 Mpa or less were found in core results taken from old buildings. Buildings can collapse under their own weight without an earthquake as a result of its low concrete strength. 1983 Diyarbakır Hicret Apartment 34 Dead), 2004 Konya Zümrüt Site (92 Dead) can be given as examples (Figure 2).

Figure 2 Failure of Zümrüt Apartment [8]

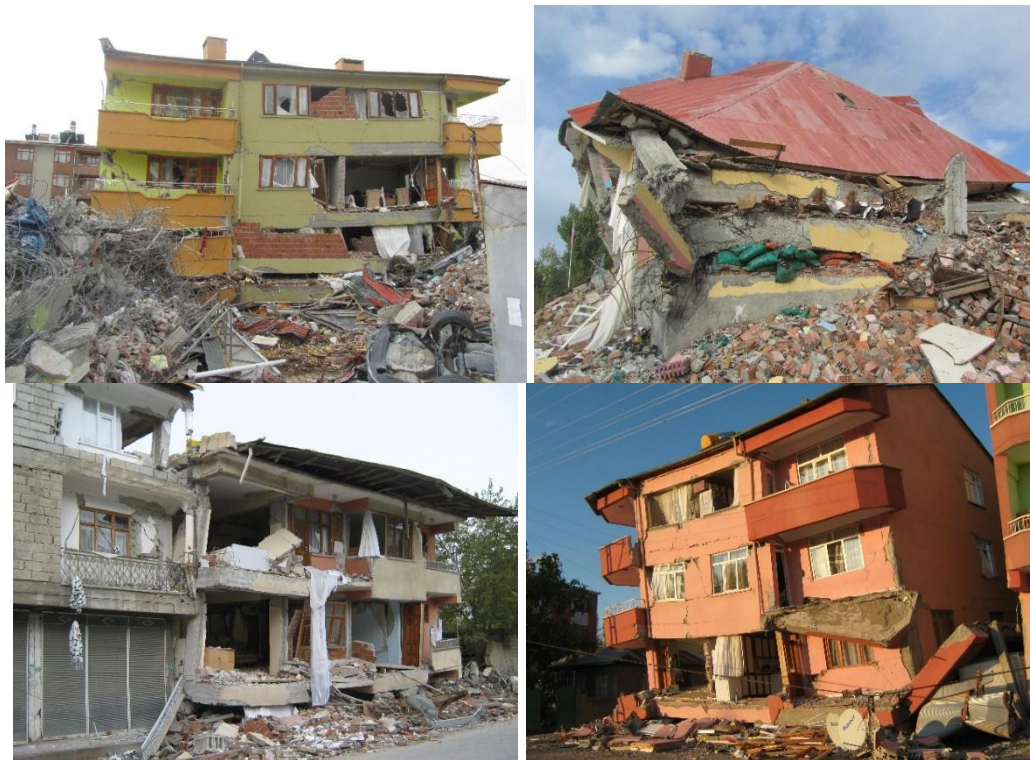
Most of the residential buildings are reinforced concrete structures. Steel or prefabricated structures are made for industrial facilities. Reinforced concrete residential buildings are mostly between 3-10 floors. In terms of the building structural load carrying system, framed structures consisting of columns and beams are common. Shear walls are not sufficient in old buildings. Insufficient lateral rigidity caused excessive damage and collapse in buildings (Figure 3). Due to the lack of lateral rigidity, significant damage occurred in the brick walls (Figure 4). In this case, it made the building difficult to use after an earthquake and significantly increased the need for temporary post earthquake housing.

Figure 3 Failure of RC building due to insufficient lateral rigidity

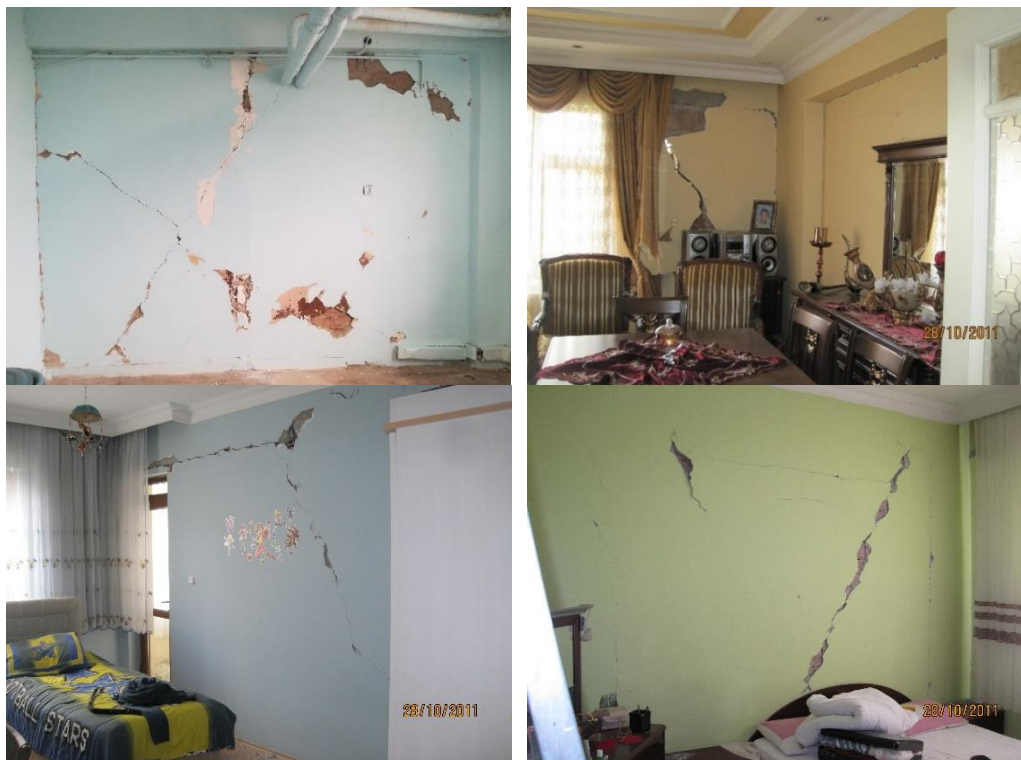
Figure 4 Excessive damage in brick infill walls

Buildings with the strength and detailing features outlined above collapsed completely even in earthquakes smaller than the design earthquake (Figure 13). The buildings were demolished with the "pancake" shaped floors overlapping. Since the brick walls were damaged heavily in buildings that had not been demolished after the earthquake, the need for temporary housing was very high (Figure 4).

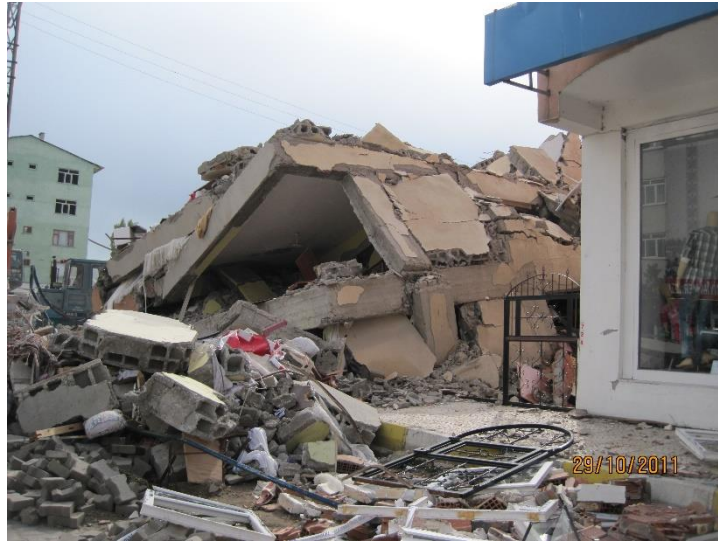
In framed structures, it is important to distribute the column stiffness equally in both vertical directions. When the column had strong axes in only one direction, significant damage occurred in the structure when the earthquake came from the other vertical direction (Figure 5).

Figure 5 Failure due to column orientation

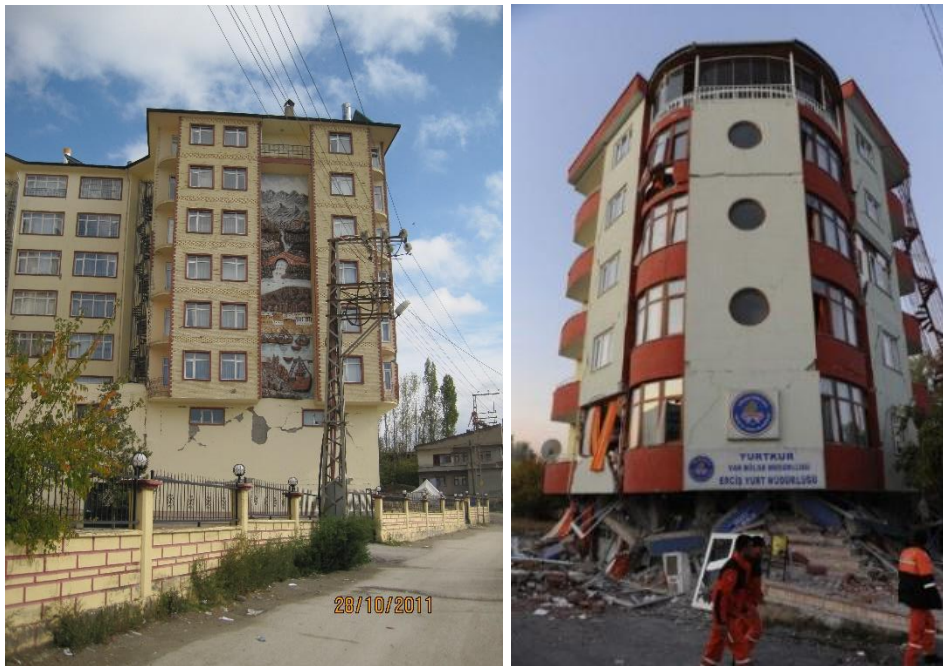
Structure geometry has a significant effect on earthquake resistance. It is difficult to provide earthquake resistance of non-symmetrical structures (Figure 6). Behavior of unsymmetrical structures under dynamic loads is very complex and to predict response of the structure require higher engineering knowledge and analysis skills.

Figure 6 Damage to unsymmetrical irregular structure

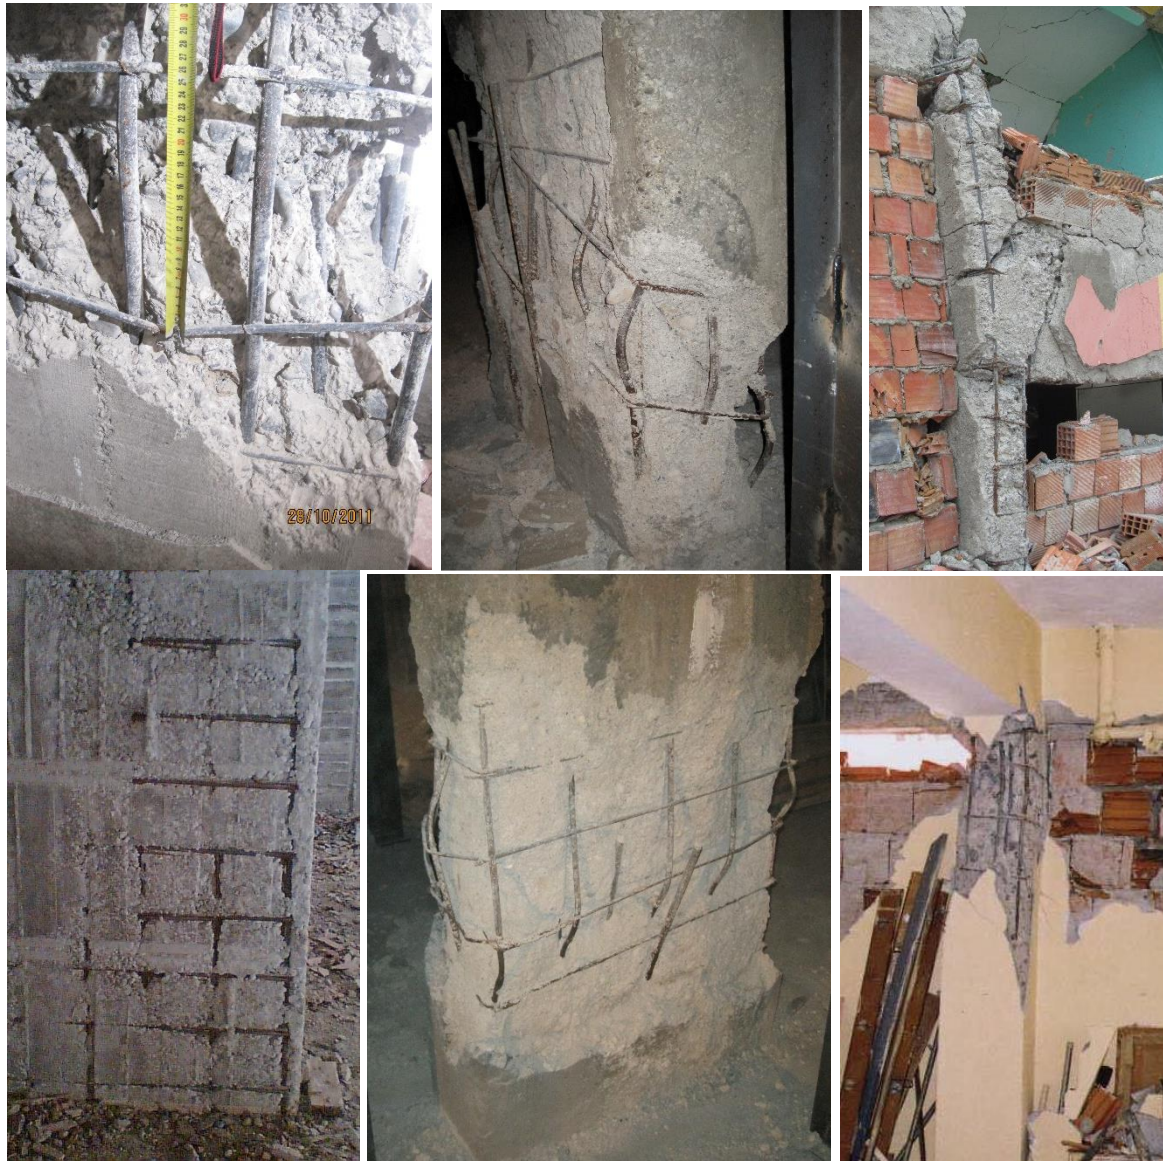
The stirrup confinement zones in columns and beams in framed structures were not complied with. Stirrup intervals were far above the ranges given in the seismic regulation (Figure 7). In addition, stirrup hooks bent 90 degrees instead of 135 degrees (Figure 8). In addition, concrete cover was not complied with in reinforced concrete elements. Insufficient cover and stirrups with 90 degree hooks were easily opened during an earthquake.

Figure 7 Stirrup intervals in columns

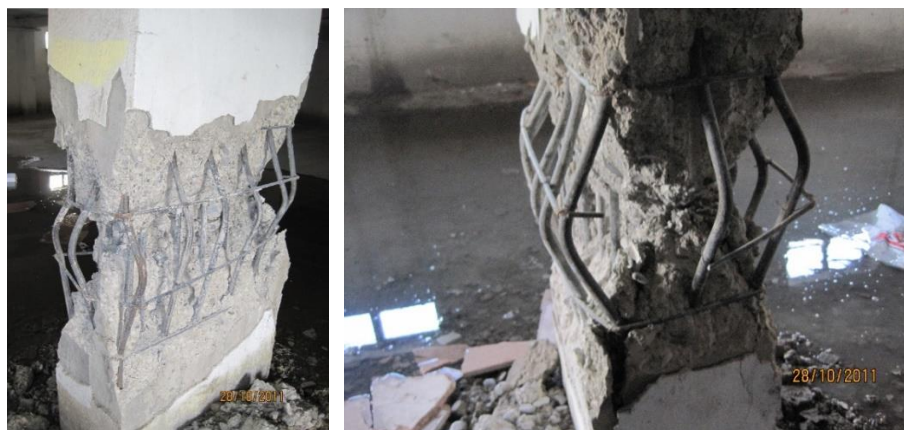
With the failure of the stirrups, the confined concrete behavior disappears. Unconfined column behavior is far from ductile properties. The deficiencies in stirrup workmanship damaged the columns in terms of both strength and ductility. It was observed that the longitudinal reinforcements buckled after the stirrup lost its effect (Figure 8).

Figure 8 Buckling of longitudinal reinforcements

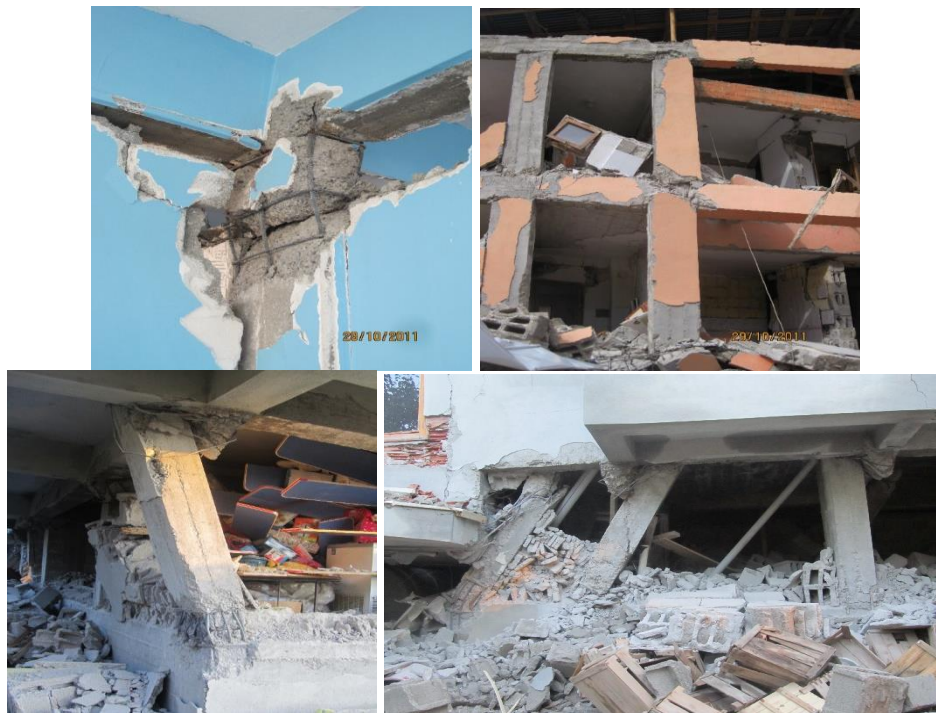
Stirrup confinement zones were often not encountered in the columns. Strong beam-weak column formation was common in column beam joints. Hinges occurred in the columns under horizontal loads. In addition,

there were no stirrups in column beam connections. Joints were far from being able to accommodate shear forces (Figure 9).

Figure 9 Failure of beam-column joints

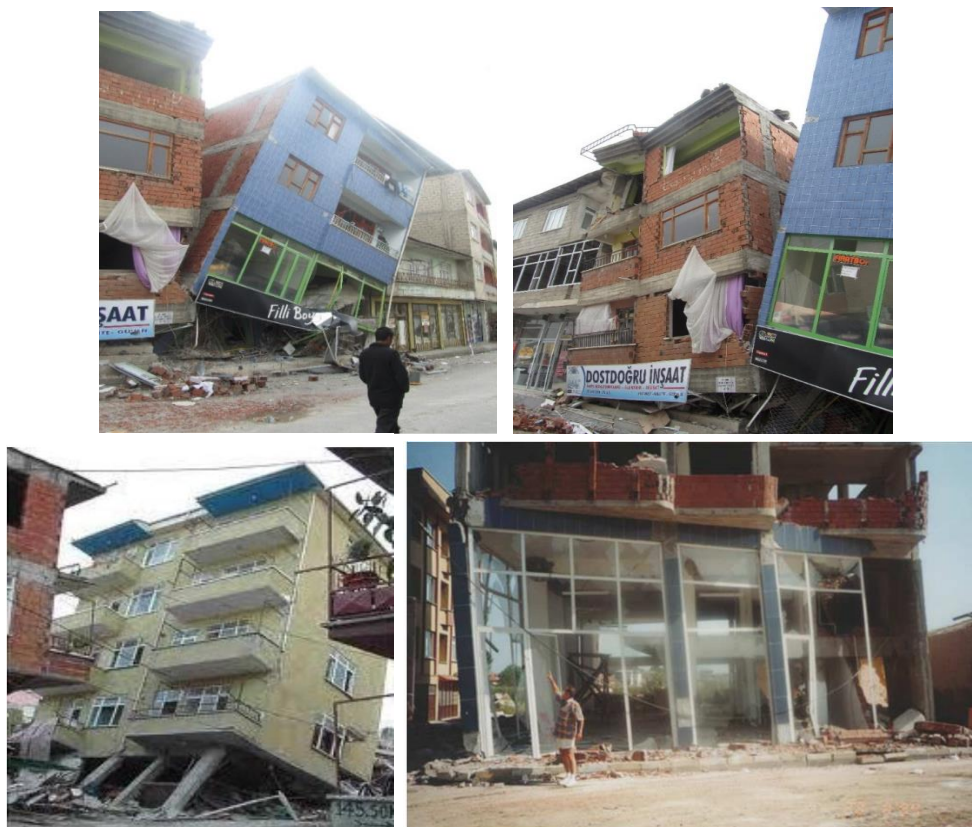
The ground floors of the buildings were generally used as shops. Brick walls on the upper floors contributed to frame rigidity. The absence of these walls on the lower floors caused irregularities in strength between the floors. Soft floor type failure was the most common type of failure under earthquake loads (Figure 10). In these structures, under horizontal loads, the joints were formed only in the lower floor columns and the system collapsed before reaching the sufficient ductility and energy consumption capacity.

Figure 10 Soft story failures [9-10]

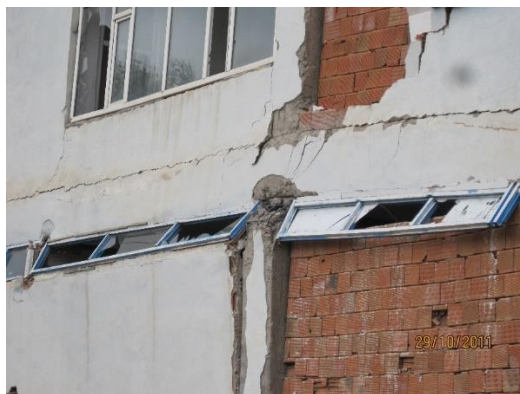
Short column formation occurred by partially building the brick walls in the frame and leaving a band-shaped window on it. Columns with a shorter length than the one considered in the design had more shear forces than the strength and the column was exposed to brittle shear fracture (Figure 11). This failure significantly decreased the ductility and strength of the building.

Figure 11 Short column failure

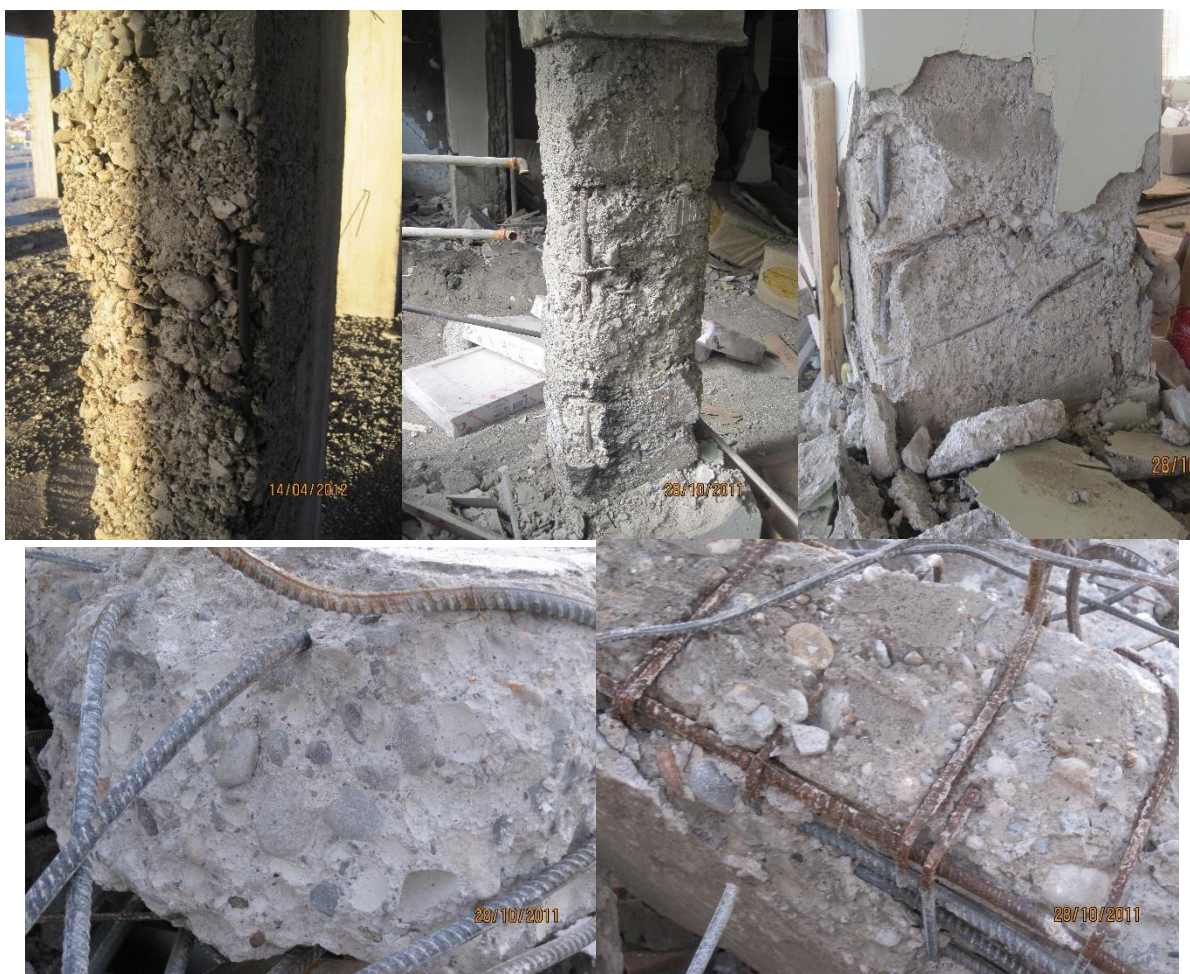
Production of concrete material was not suitable for technique. Concrete was mostly produced on site by machine or by hand mixed by workers. It was not possible to comply with the concrete mix calculation. The cement dosage and water/cement ratio were performed by the workers' own initiative. Therefore, concrete strengths fall down to 7 MPa. Rounded coarse aggregates were used in concrete. There is no bond between cement paste and aggregate. As a result of low concrete strength, reinforcement adherence does not occur (Figure 12).

Figure 12 Concrete material condition in RC buildings

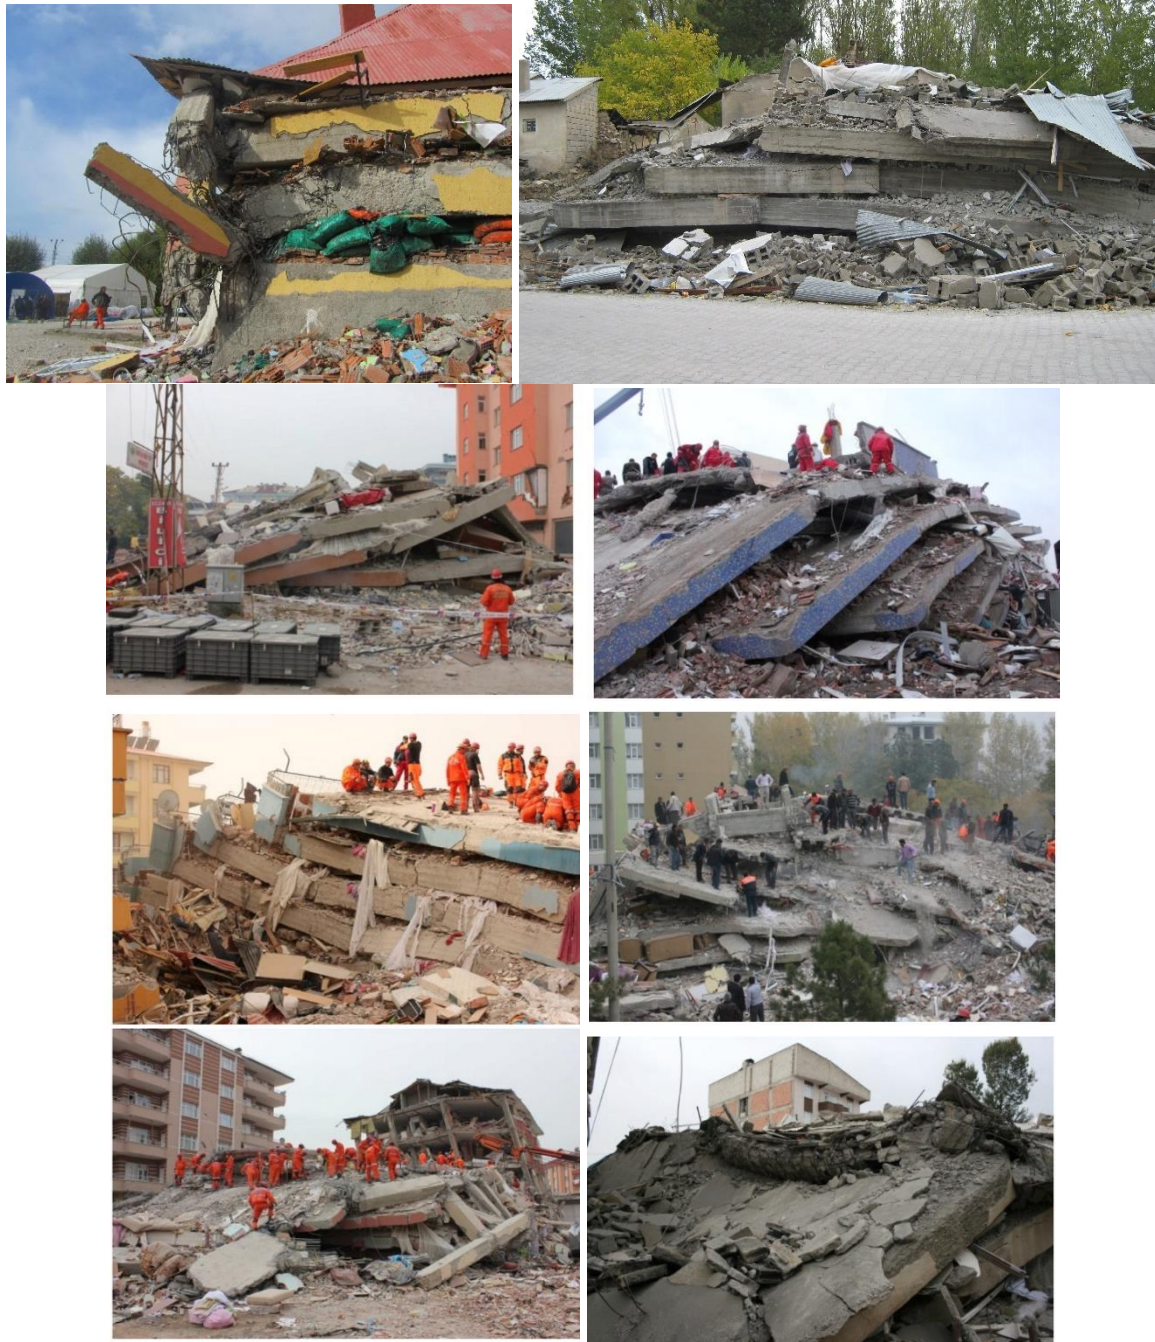
Figure 13 Pancake Collapse of RC structures [11]
