Behavior of Slab-on-Grade Resting on Expansive Soil

Abstract

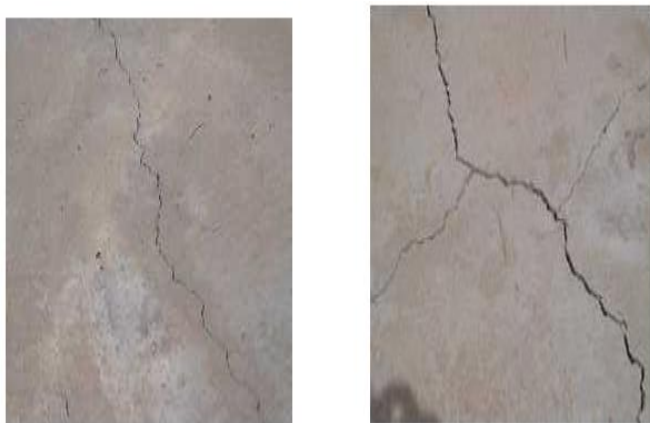
The slabs on grade were built in January 2017 without accounting for the uplift forces caused by soil heaving. Following a month of heavy rainfall, uneven movement of the expansive fill material occurred, with the most significant uplift at the center of the slabs and minimal movement at the corners. This differential heaving of up to 120 mm created substantial stresses that exceeded allowable limits, resulting in typical patterns of wide cracks in both one-way and two-way slabs. At the corners of the two-way slabs, torsional cracks were observed due to warping effects, as illustrated in Figures 3, 4, and 5. To estimate the pressure exerted by the expansive clay on the slabs, an approach described in [5] is applied, using the two-way slab S3 as a representative case. Nayak and Christensen state that the pressure

Fig 3. Typical crack pattern of one- and two-way slabs

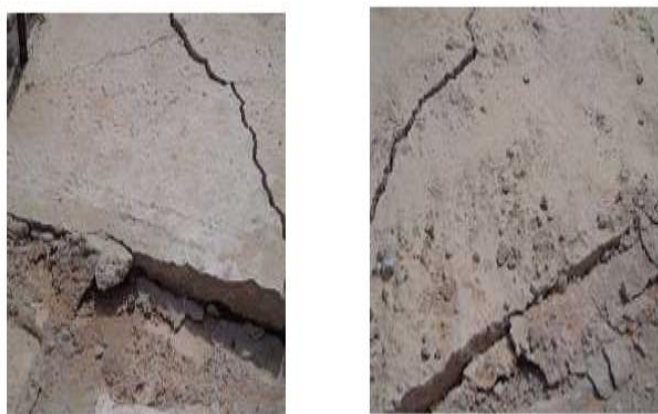
Fig 4. Cracks at the corners of slab S1 due to warping

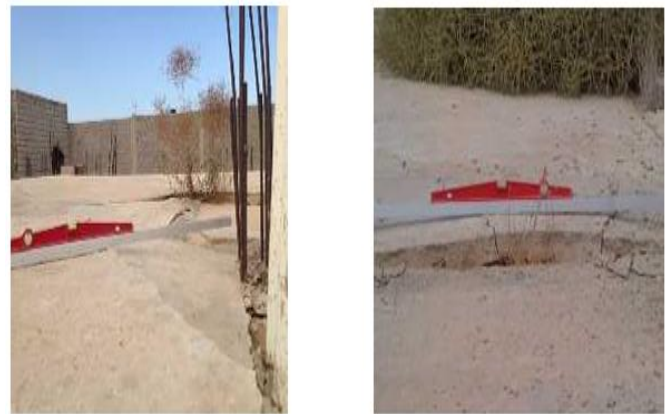
In February 2017, after a month of heavy rainfall, the expansive clay began to swell, causing differential upward movement of the slabs, with the maximum displacement reaching 120 mm at the center and nearly zero at the corners. The authors conducted regular site visits to assess the damage to the structure and gather information about both the supporting soil and the fill material used. This included inspecting nearby buildings and the area's soil profile. No damage from settlement or heave was observed in the surrounding buildings. Based on their experience, the authors confirmed the high bearing capacity of the underlying layer. These observations indicated that the primary cause of the cracks in the building was the heaving of the imported fill material. To investigate the characteristics and swelling potential of this soil, the authors collected three representative samples from various locations, as shown in Figure 1. The samples were promptly transported to the civil engineering department's laboratories for testing. Once there, the soil samples were air-dried, crushed, and sieved through a 2 μ m sieve, then stored in a sealed container for several days to equalize their moisture content prior to the testing program.

Fig 5. Differential heaving of slab S1
