Behavior of Slab-on-Grade Resting on Expansive Soil

Abstract

This paper discusses a case study of a residential building in Benghazi that features slab-on-grade foundations supported by expansive soils. Although such structures are uncommon in the area, they can suffer serious damage due to volumetric changes in the soil caused by wetting and drying. The building has a total plan area of 200 m², with tie beams located 1.2 m above the formation level, and expansive soil used as backfill. After being moistened and lightly compacted, 100 mm thick concrete slabs were poured between the tie beams, resulting in varying slab sizes. Following a month of heavy rainfall, significant cracking—longitudinal, diagonal, and warping—occurred in the slabs due to uneven deformation from the expansive soil. The paper includes photographs of these deformations and cracks, along with an analysis of the geotechnical properties of the expansive soil, including its swelling and shrinking characteristics. It also employs an approach to predict the pressure exerted on the slabs due to differential heave.

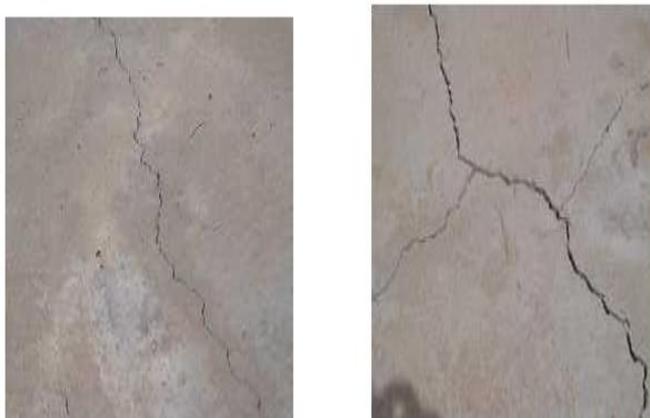
Fig 3. Typical crack pattern of one- and two-way slabs

The slabs on grade were built in January 2017 without accounting for the uplift forces caused by soil heaving. Following a month of heavy rainfall, uneven movement of the expansive fill material occurred, with the most significant uplift at the center of the slabs and minimal movement at the corners. This differential heaving of up to 120 mm created substantial stresses that exceeded allowable limits, resulting in typical patterns of wide cracks in both one-way and two-way slabs. At the corners of the two-way slabs, torsional cracks were observed due to warping effects, as illustrated in Figures 3, 4, and 5. To estimate the pressure exerted by the expansive clay on the slabs, an approach described in [5] is applied, using the two-way slab S3 as a representative case. Nayak and Christensen state that the pressure

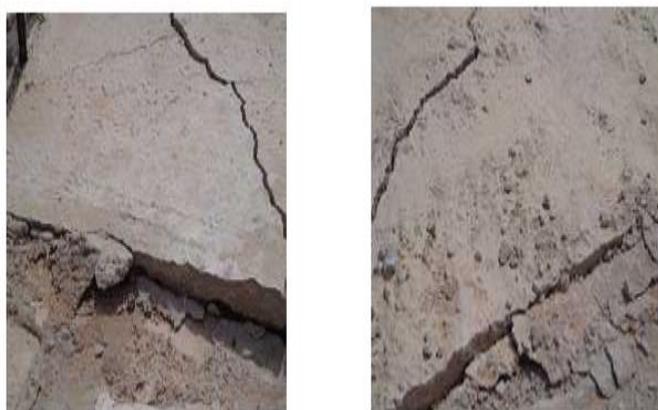
Fig 4. Cracks at the corners of slab S1 due to warping

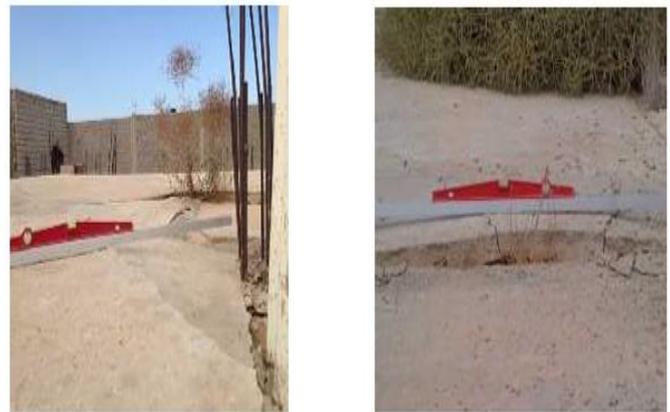
Fig 5. Differential heaving of slab S1

In February 2017, after a month of heavy rainfall, the expansive clay began to swell, causing differential upward movement of the slabs, with the maximum displacement reaching 120 mm at the center and nearly zero at the corners. The authors conducted regular site visits to assess the damage to the structure and gather information about both the supporting soil and the fill material used. This included inspecting nearby buildings and the area's soil profile. No damage from settlement or heave was observed in the surrounding buildings. Based on their experience, the authors confirmed the high bearing capacity of the underlying layer. These observations indicated that the primary cause of the cracks in the building was the heaving of the imported fill material. To investigate the characteristics and swelling potential of this soil, the authors collected three representative samples from various locations, as shown in Figure 1. The samples were promptly transported to the civil engineering department's laboratories for testing. Once there, the soil samples were air-dried, crushed, and sieved through a 2 μ m sieve, then stored in a sealed container for several days to equalize their moisture content prior to the testing program.
